aquadrive
antivibration system

Repair manual, CV Shafts

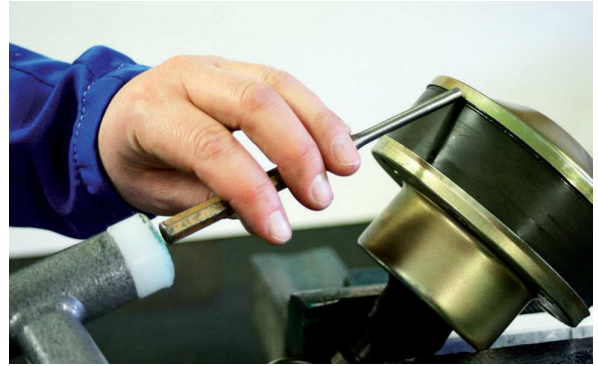
2. Remove end covers on both sides of CV-joint

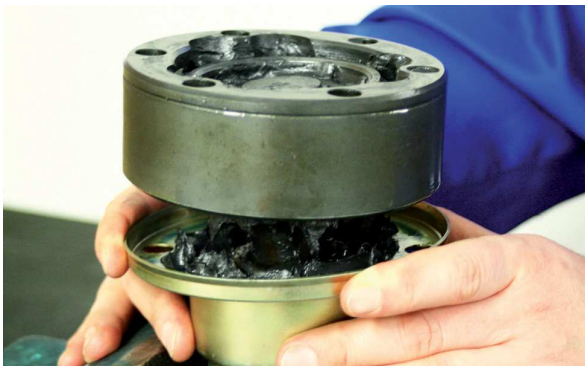
3. Press inside end cover with boot down the intermediate shaft

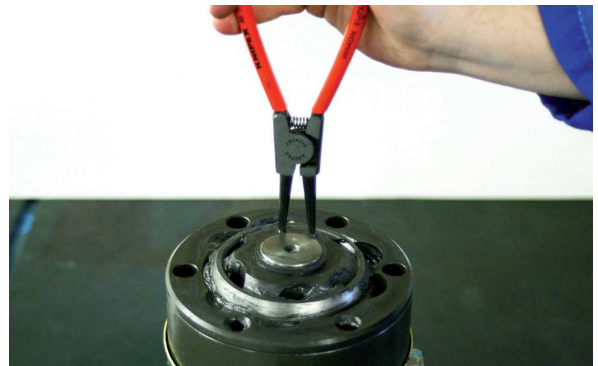
4. Remove locking

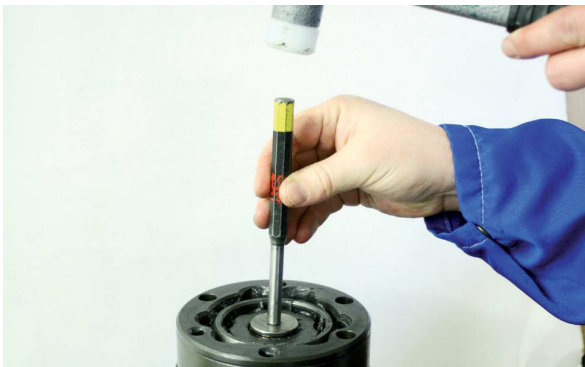
5. Carefully drive intermediate shaft out off CV-joint

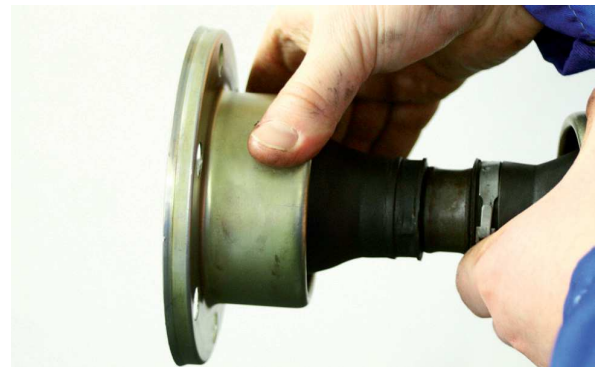
6. Remove boot

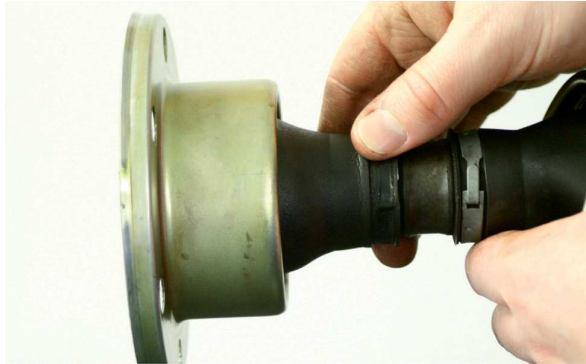
7. Fit new boot

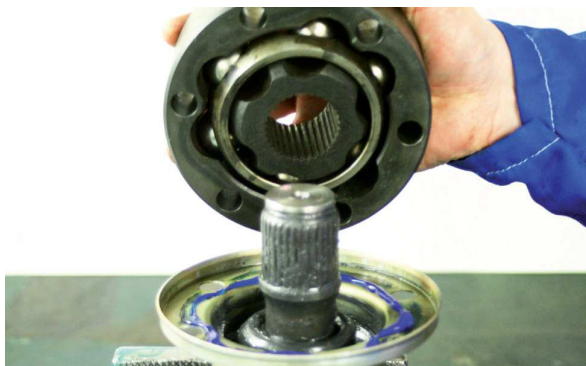
9. Fit CV-joint on shaft, lining up the splines. N.B. Do not forget gasket between inside end cover and CV-joint.

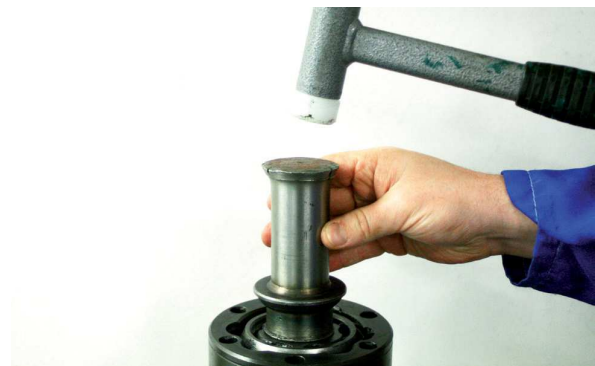
10. Carefully drive ball hub onto shaft until it reaches bottom position

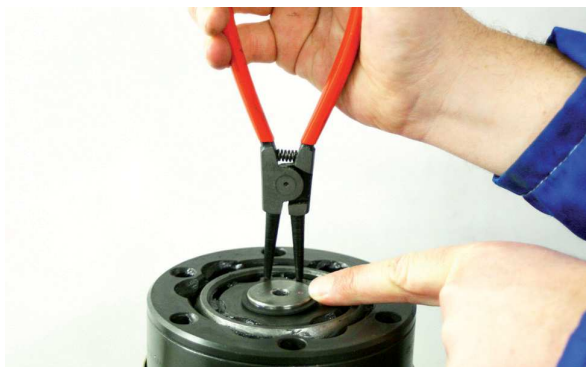
11. Fit new circlip

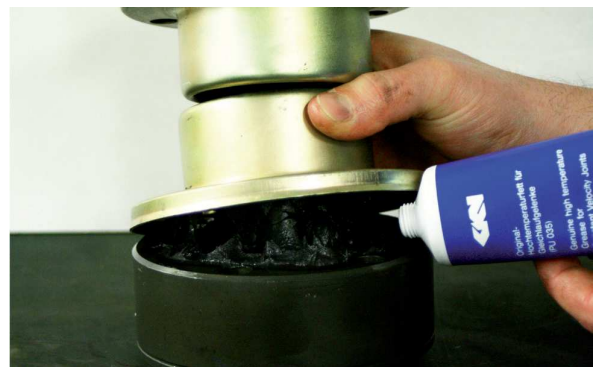
12. Fill inside of CV-joint with approx. half the grease supplied

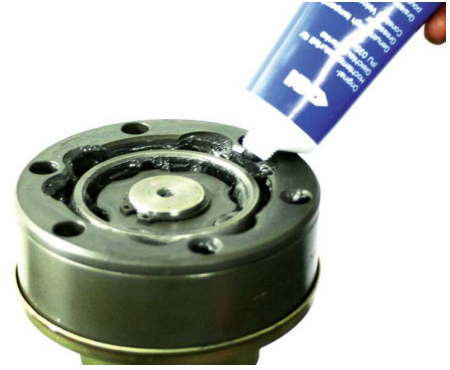
14. Fill remaining grease in CV-joint outside

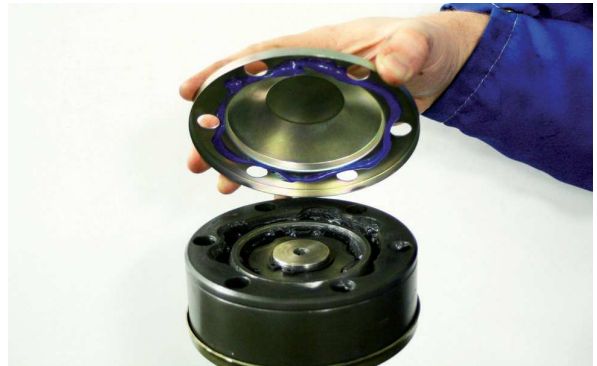
16. Put outside cover on CV-joint with holes lining up

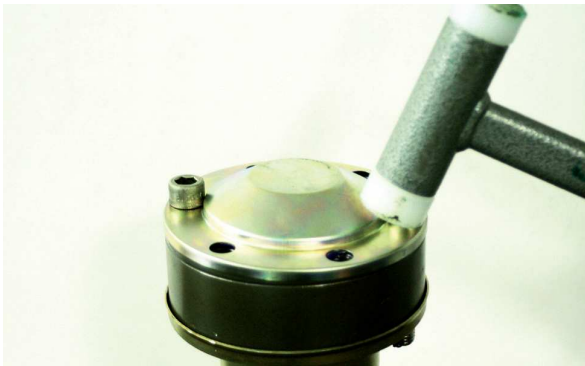
17. Use plastic hammer carefully
